PRESTRESSED CONCRETE TEE BEAMS WITH  
LARGE WEB OPENINGS

A THESIS

DEPARTMENT OF CIVIL ENGINEERING  
EDMONTON, ALBERTA

FALL, 1970

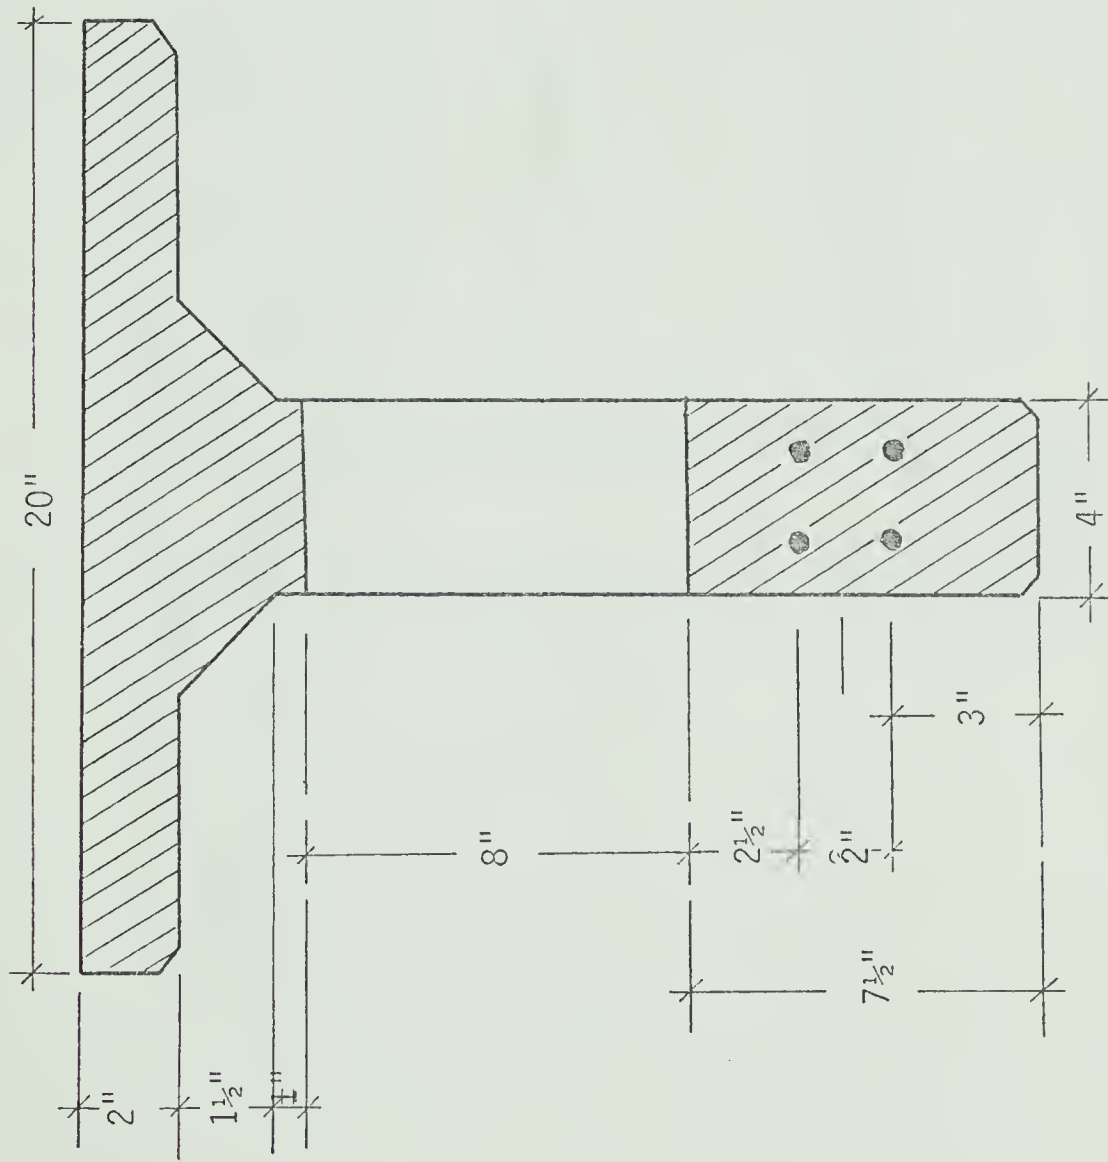
FIGURE 3.1 TYPICAL CONCRETE X-SECTION AT AN OPENING

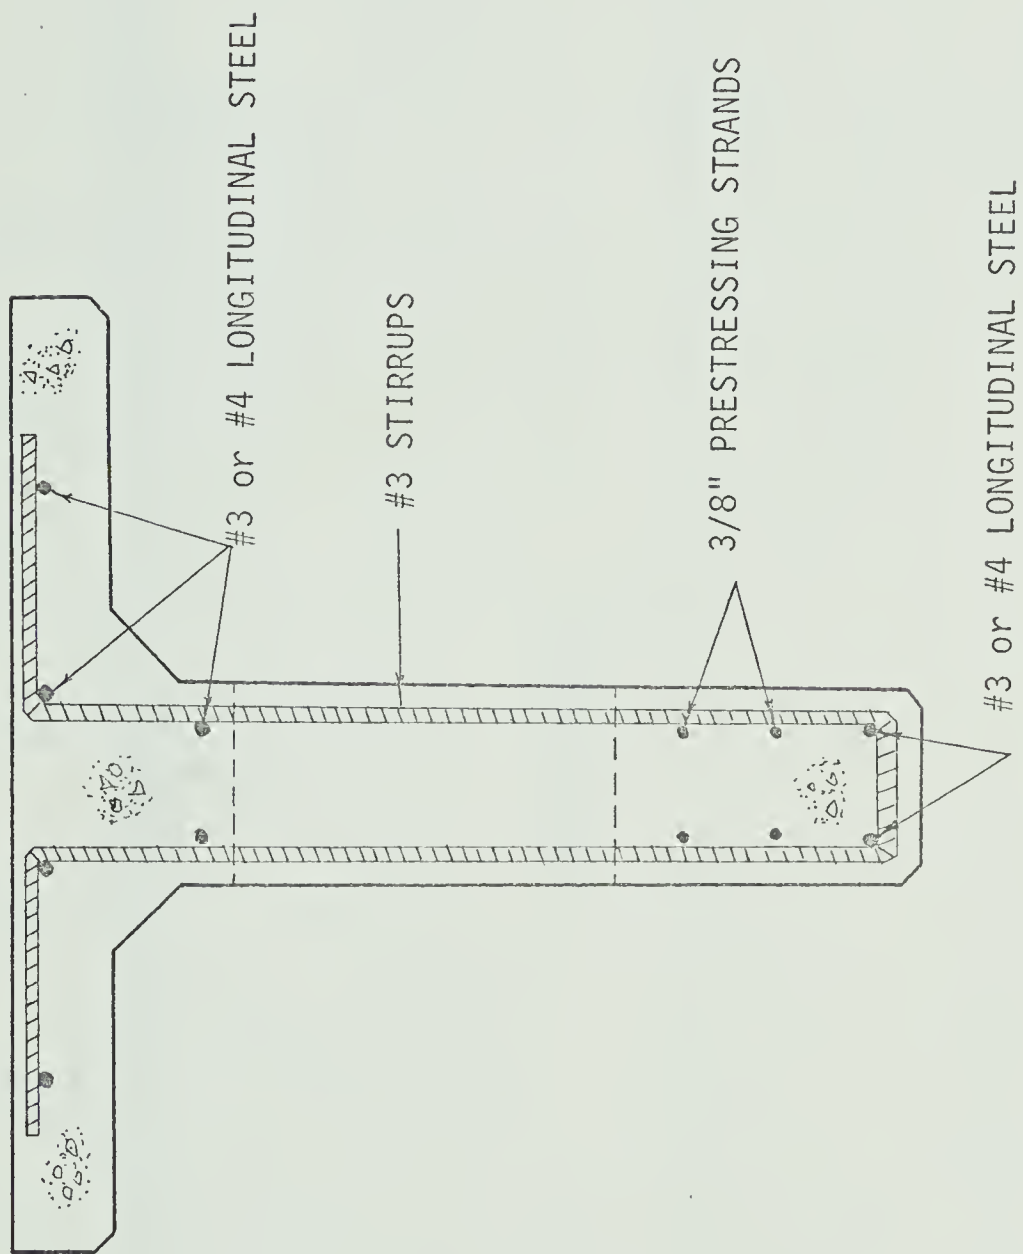
FIGURE 3.2 TYPICAL BEAM REINFORCEMENT DETAIL

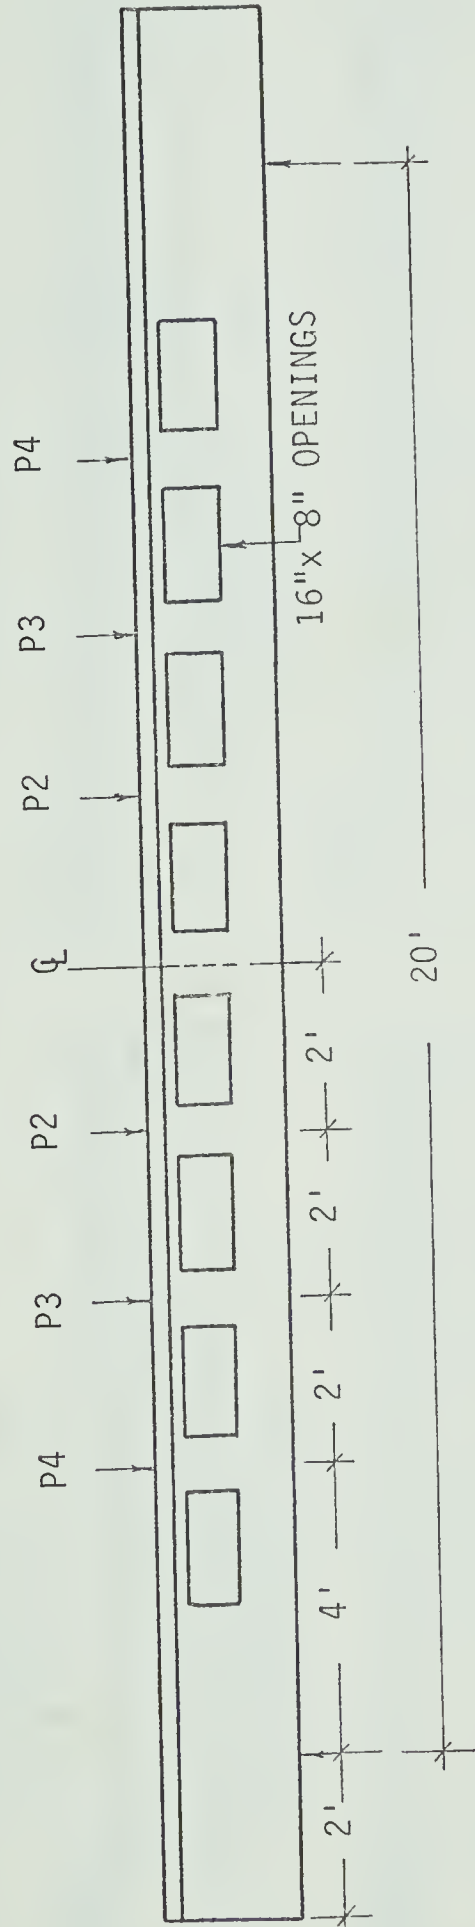
FIGURE 3.3 POSITIONS OF APPLIED TWO POINT LOADS

Varying the load position had the effect of changing the applied shear to maximum moment conditions; that is, load position 4 resulted in a more severe shear to moment condition than load 2 which resulted in a less severe condition relative to moment. Load position 3, however resulted in an average shear to flexure condition which might best represent the moment condition found in most structures, which would result from a uniformly distributed load.

However, the shear condition produced by load position 3 is much more severe than that corresponding to a uniformly distributed load.

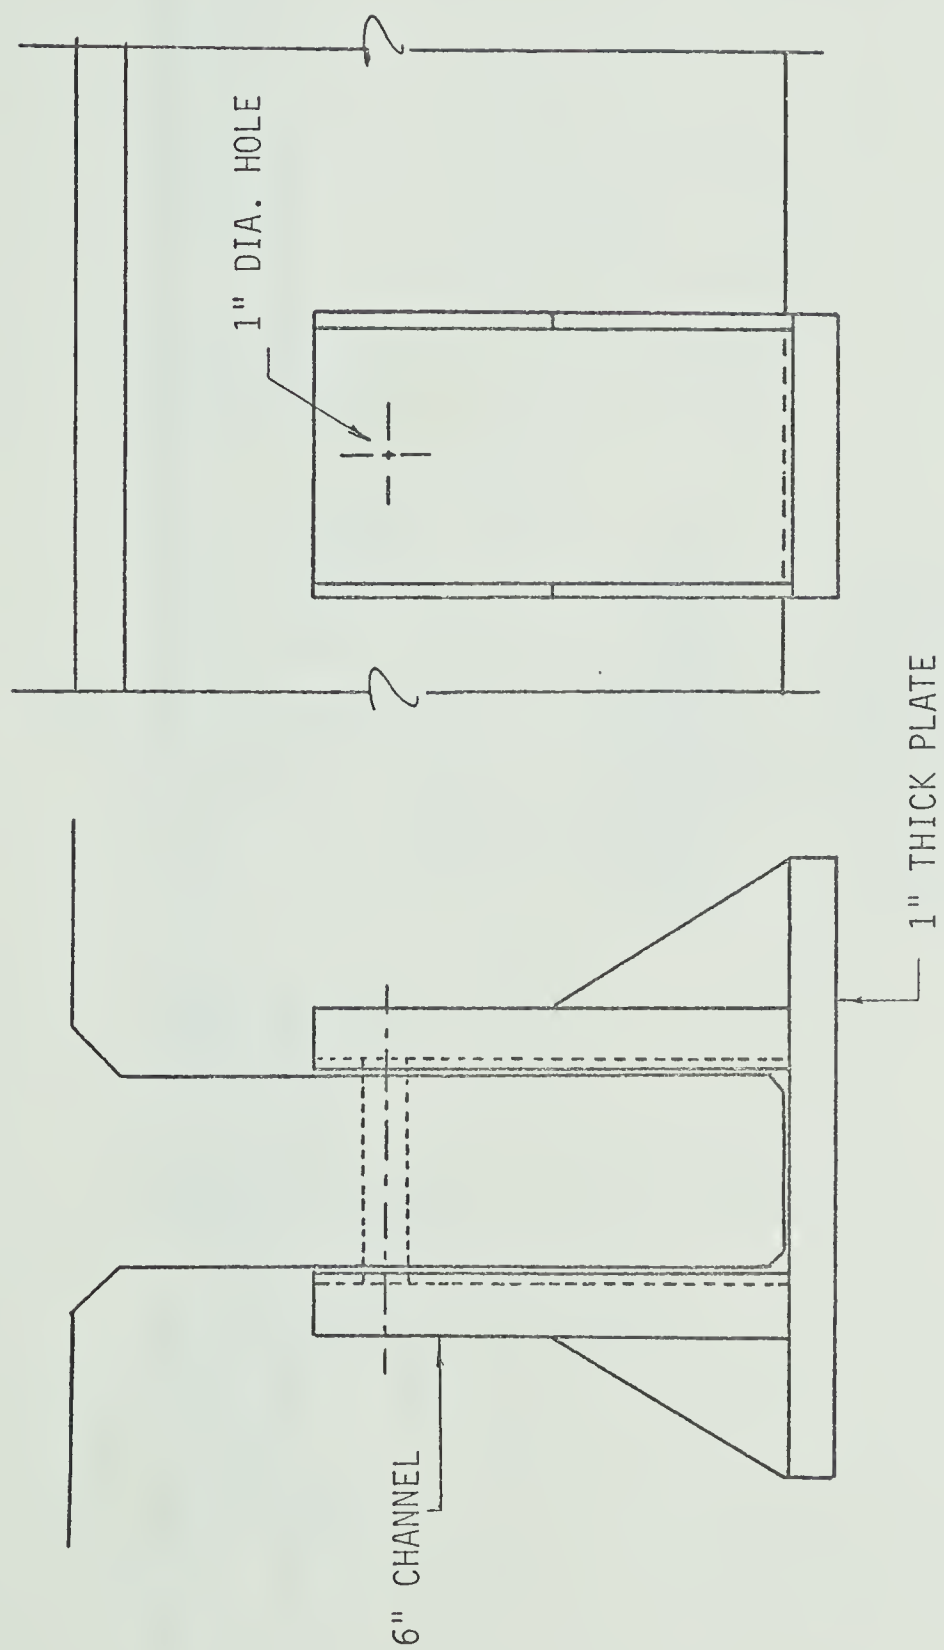
FIGURE 3.5 FRONT AND SIDE ELEVATIONS OF TYPICAL BEAM SEATS

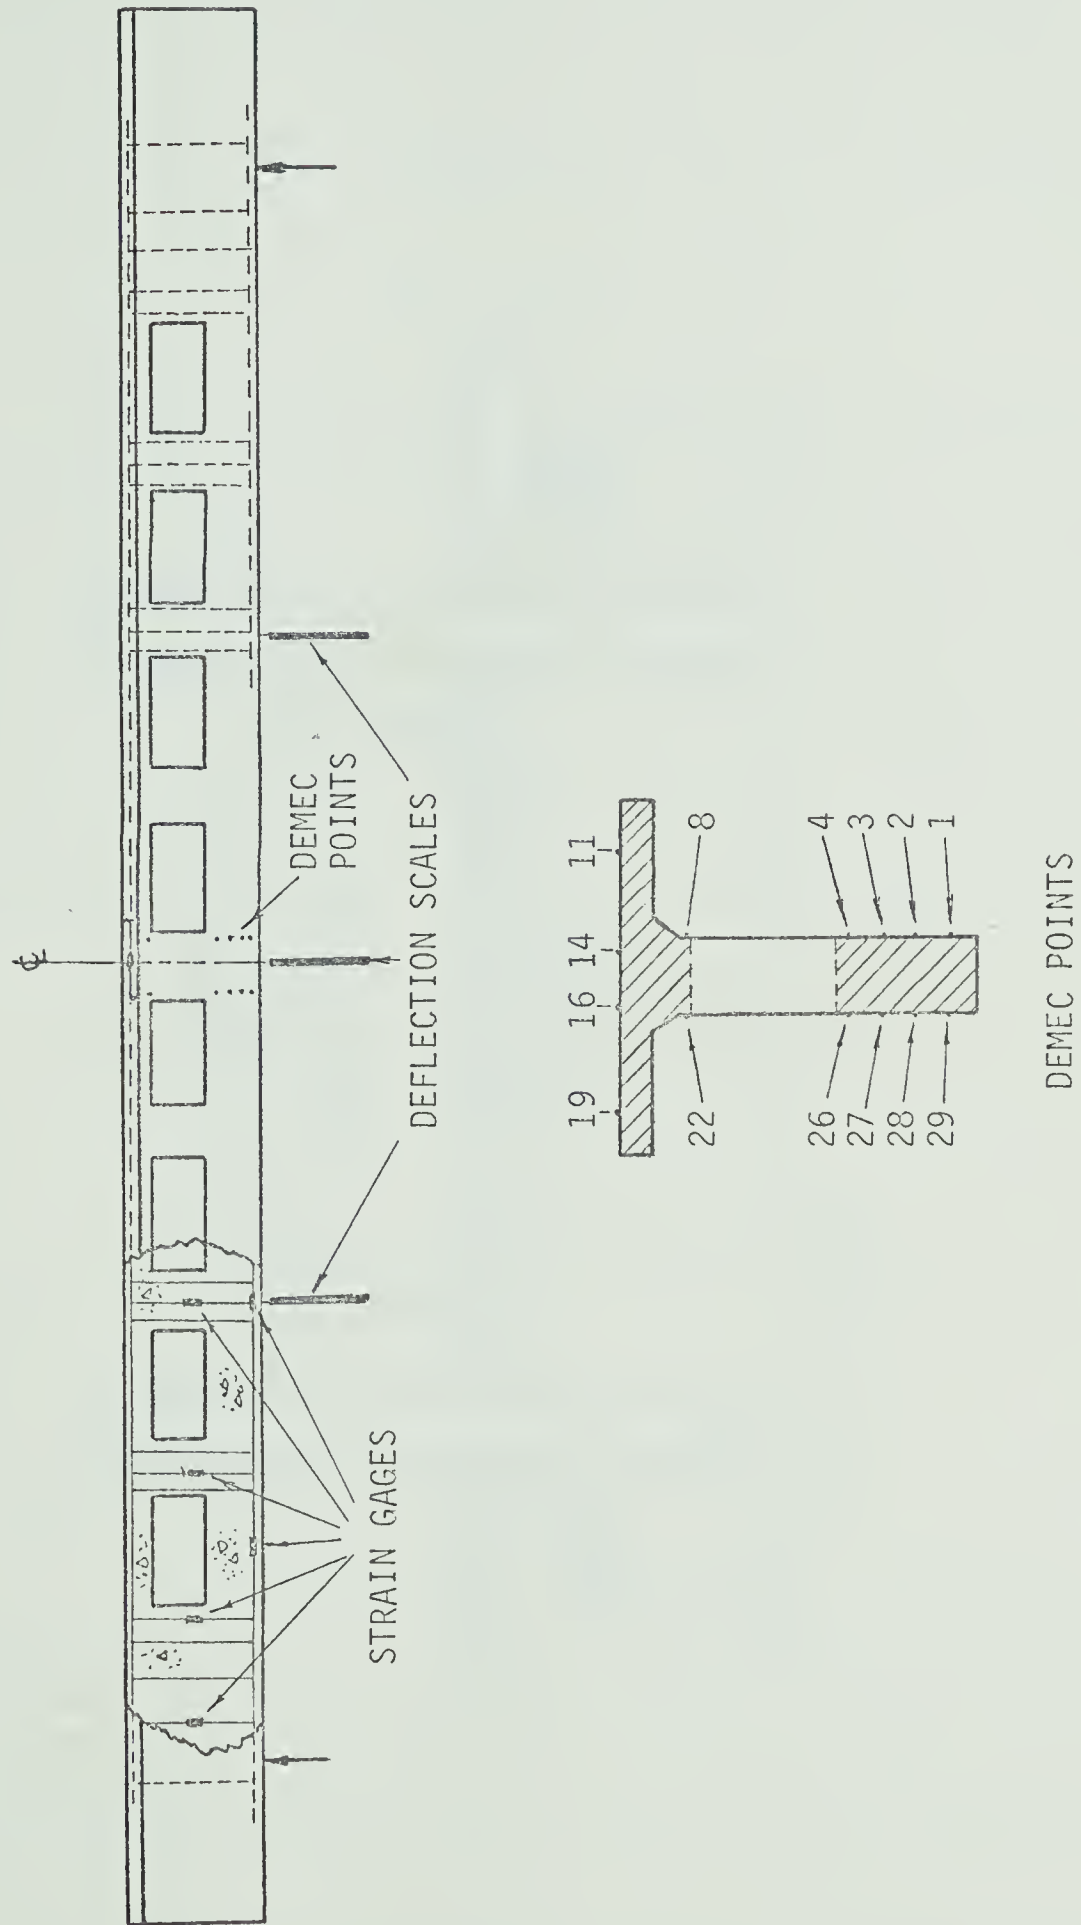
FIGURE 3.6 BEAM INSTRUMENTATION DETAILS AND LOCATIONS

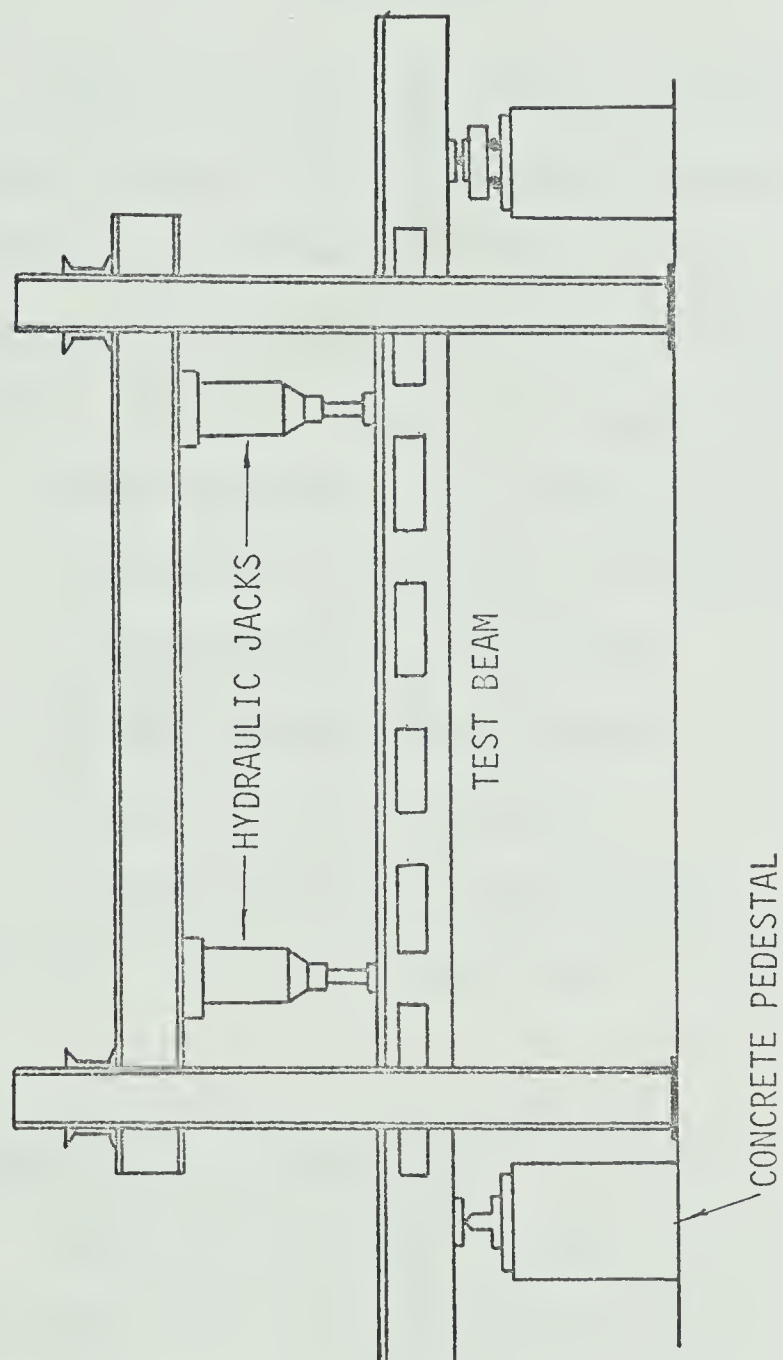
FIGURE 3.7 LOADING FRAME AND TEST SET-UP

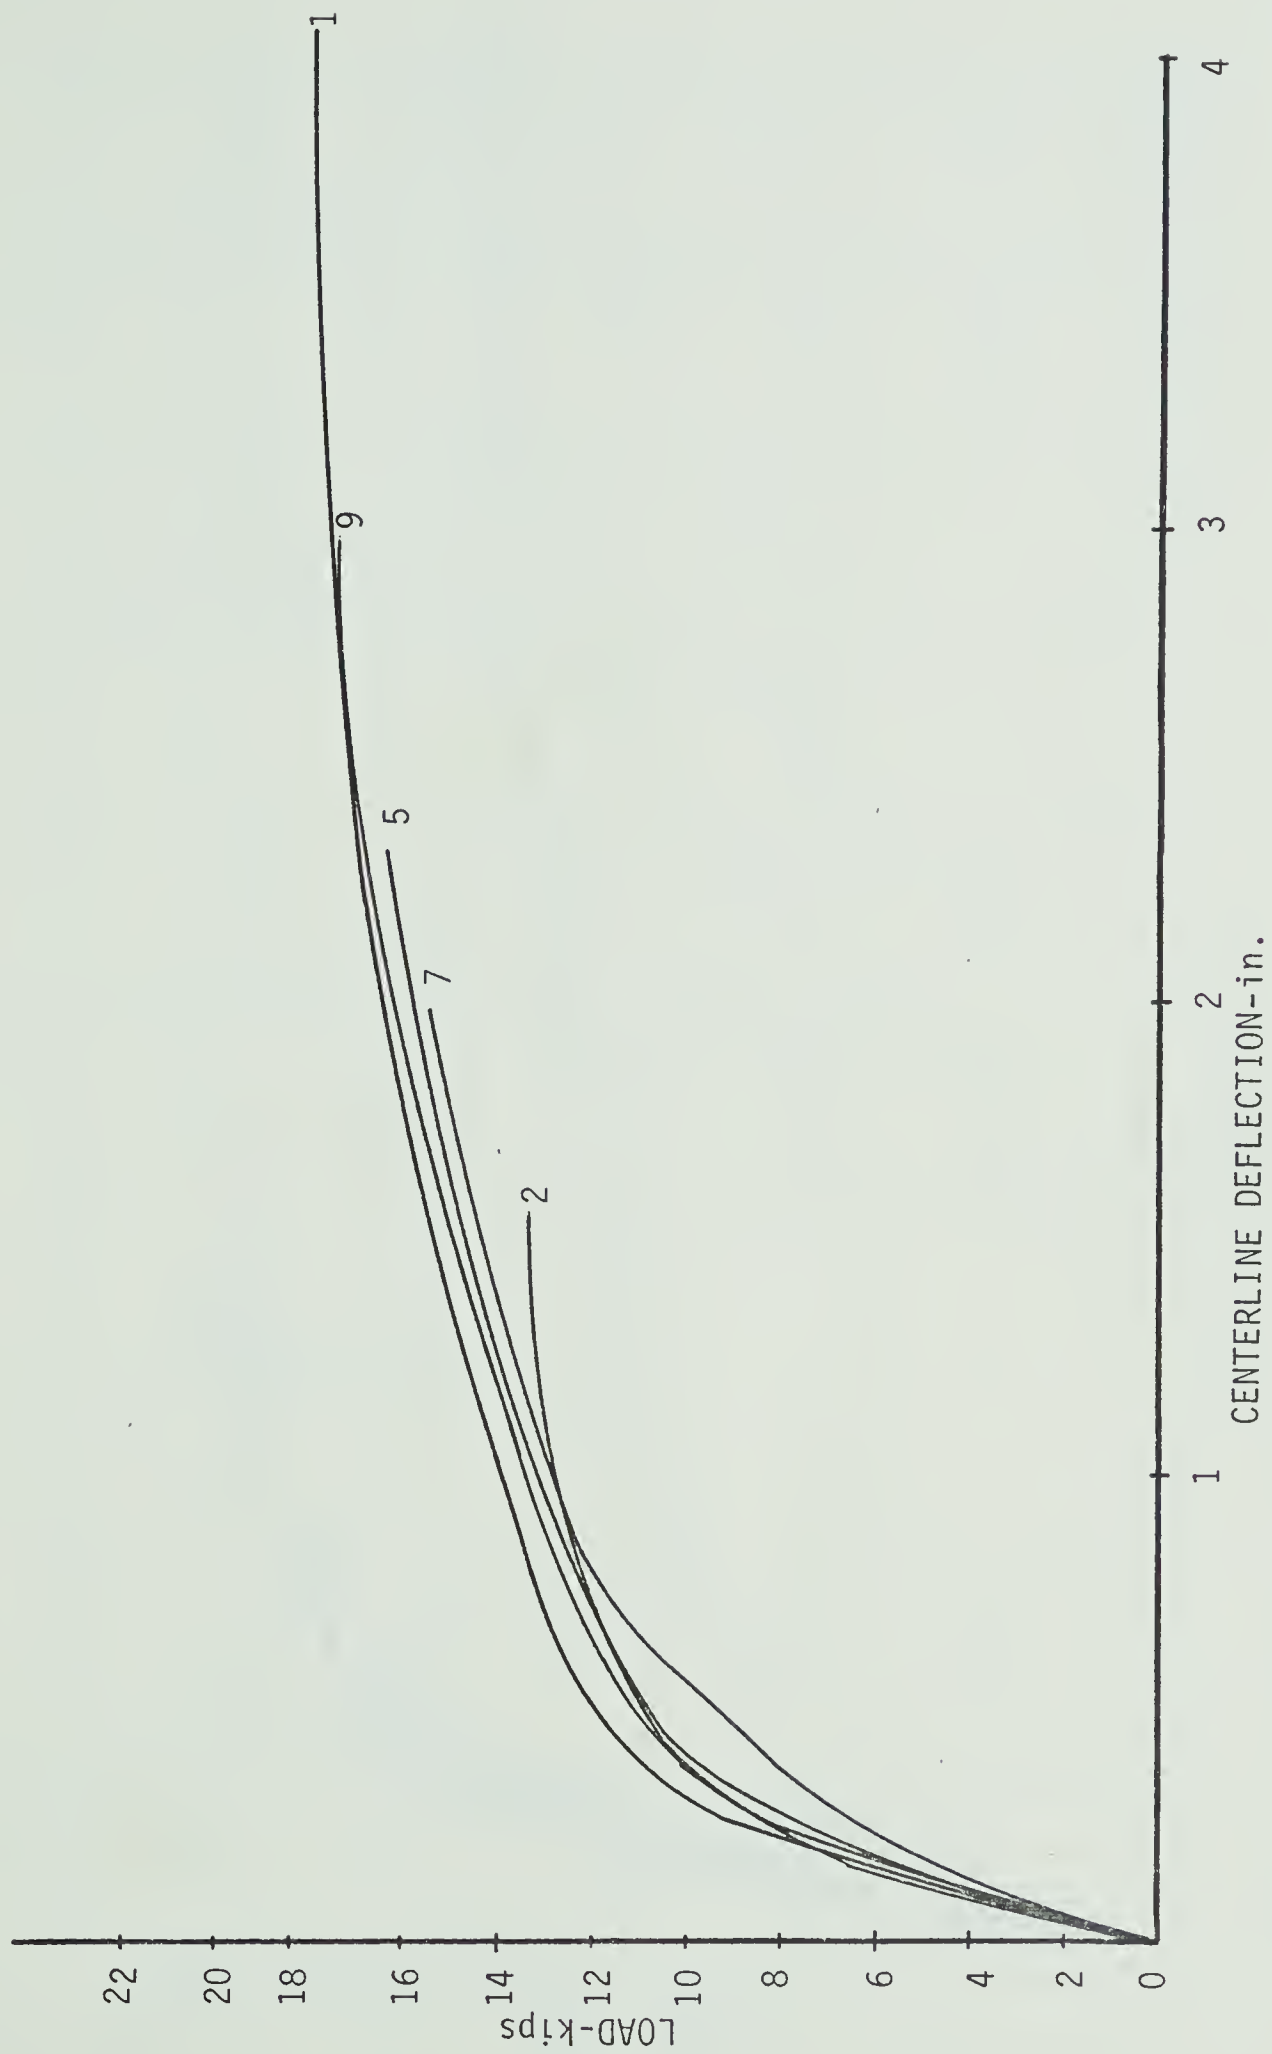
FIGURE 4.1 (a) LOAD-DEFLECTION DIAGRAM FOR BEAMS OF LOAD GROUP 3

rupts per post, being equivalent to having the stirrups spaced at 8 in. in a beam containing no holes. The beam's load-deflection curve in Fig. 4.1 (a) shows that it sustained smaller deflections than beam #2 for the same load. Strain distribution diagrams at centerline show that, at the extreme fibers, the strains are approximately half of those of the control beam. The linearity of strains within the web of beam #1 however, is not attained in beam #5. The presence of the openings caused remarkable strain disruptions over the depth of the section. This phenomenon was also observed when the beam was undergoing cracking; some of the flexural cracks in the centerspan, between jack loads of 11.5 and 16.0 kips, were observed to commence at the top fiber of the lower web and to work down toward the bottom fibers of the beam. These cracks were a direct result of the flexural stress concentrations at the edges of the openings.

Beam #9 was reinforced similarly to #7, except that it was also provided with 2#3 inclined U-stirrups in the two lower webs in each shear span. From Fig. 4.1 (a) it can be observed that the beam's load-deflection behaviour was very similar to that of the control beam. Beam #9, when compared to beams #5 and 7, was observed to exhibit smaller deflections at any given load up to approximately 16.5 kips.

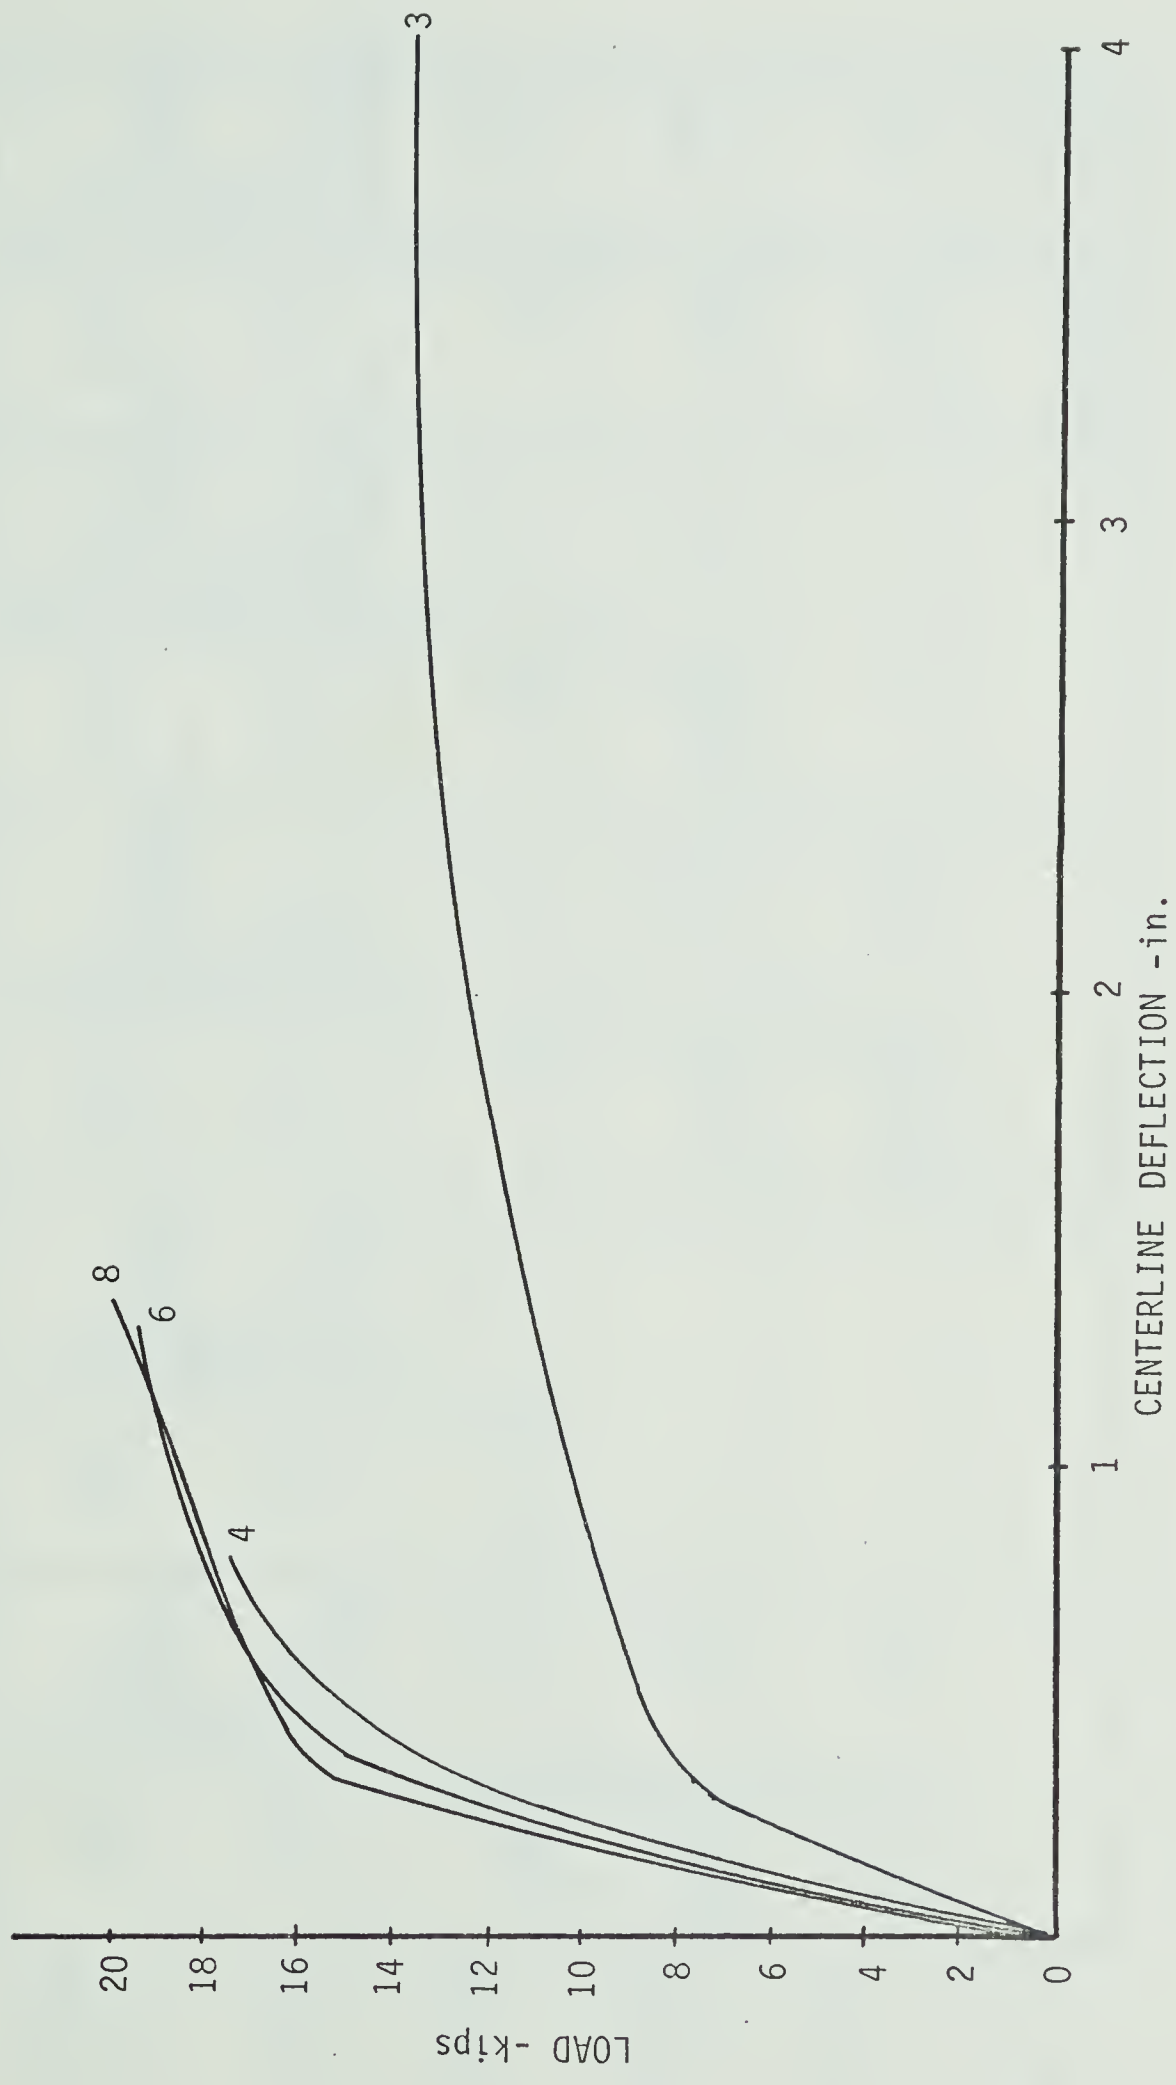
FIGURE 4.1 (b) LOAD-DEFLECTION DIAGRAM FOR BEAMS OF LOAD GROUPS 2&4

tion curves for the beams grouped according to load position 3 and load positions 4,2 respectively. It should be noted that the load-deflection curve for beam #1 is not complete as this beam was unloaded and reloaded to failure the next day. Individual load-deflection diagrams for the beams are presented in Appendix B.

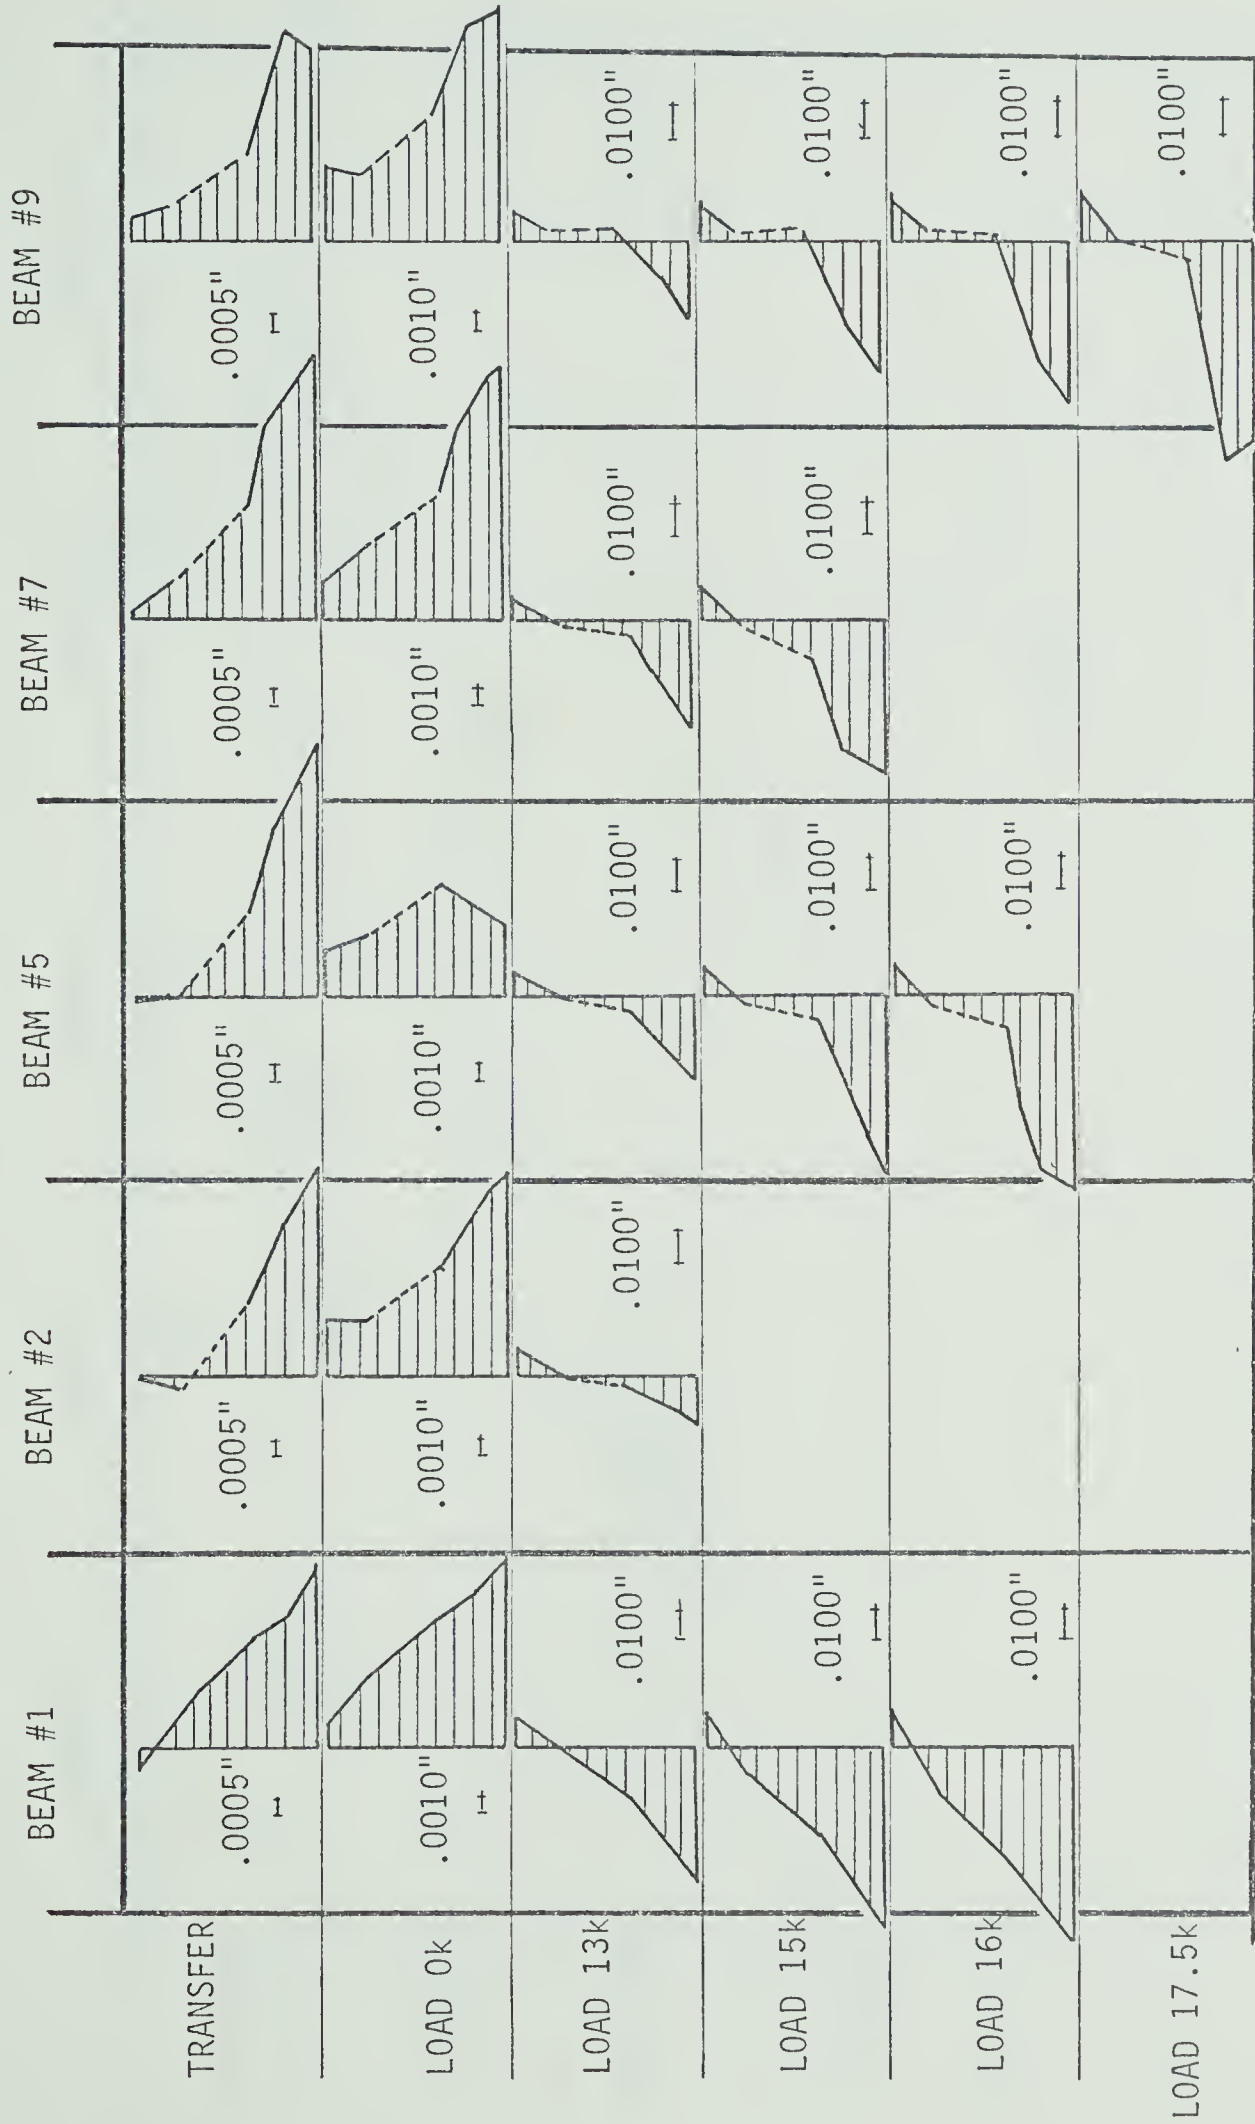
FIGURE 4.2 (a) STRAIN DISTRIBUTIONS AT  $\zeta$  FOR BEAMS OF LOAD GROUP #3

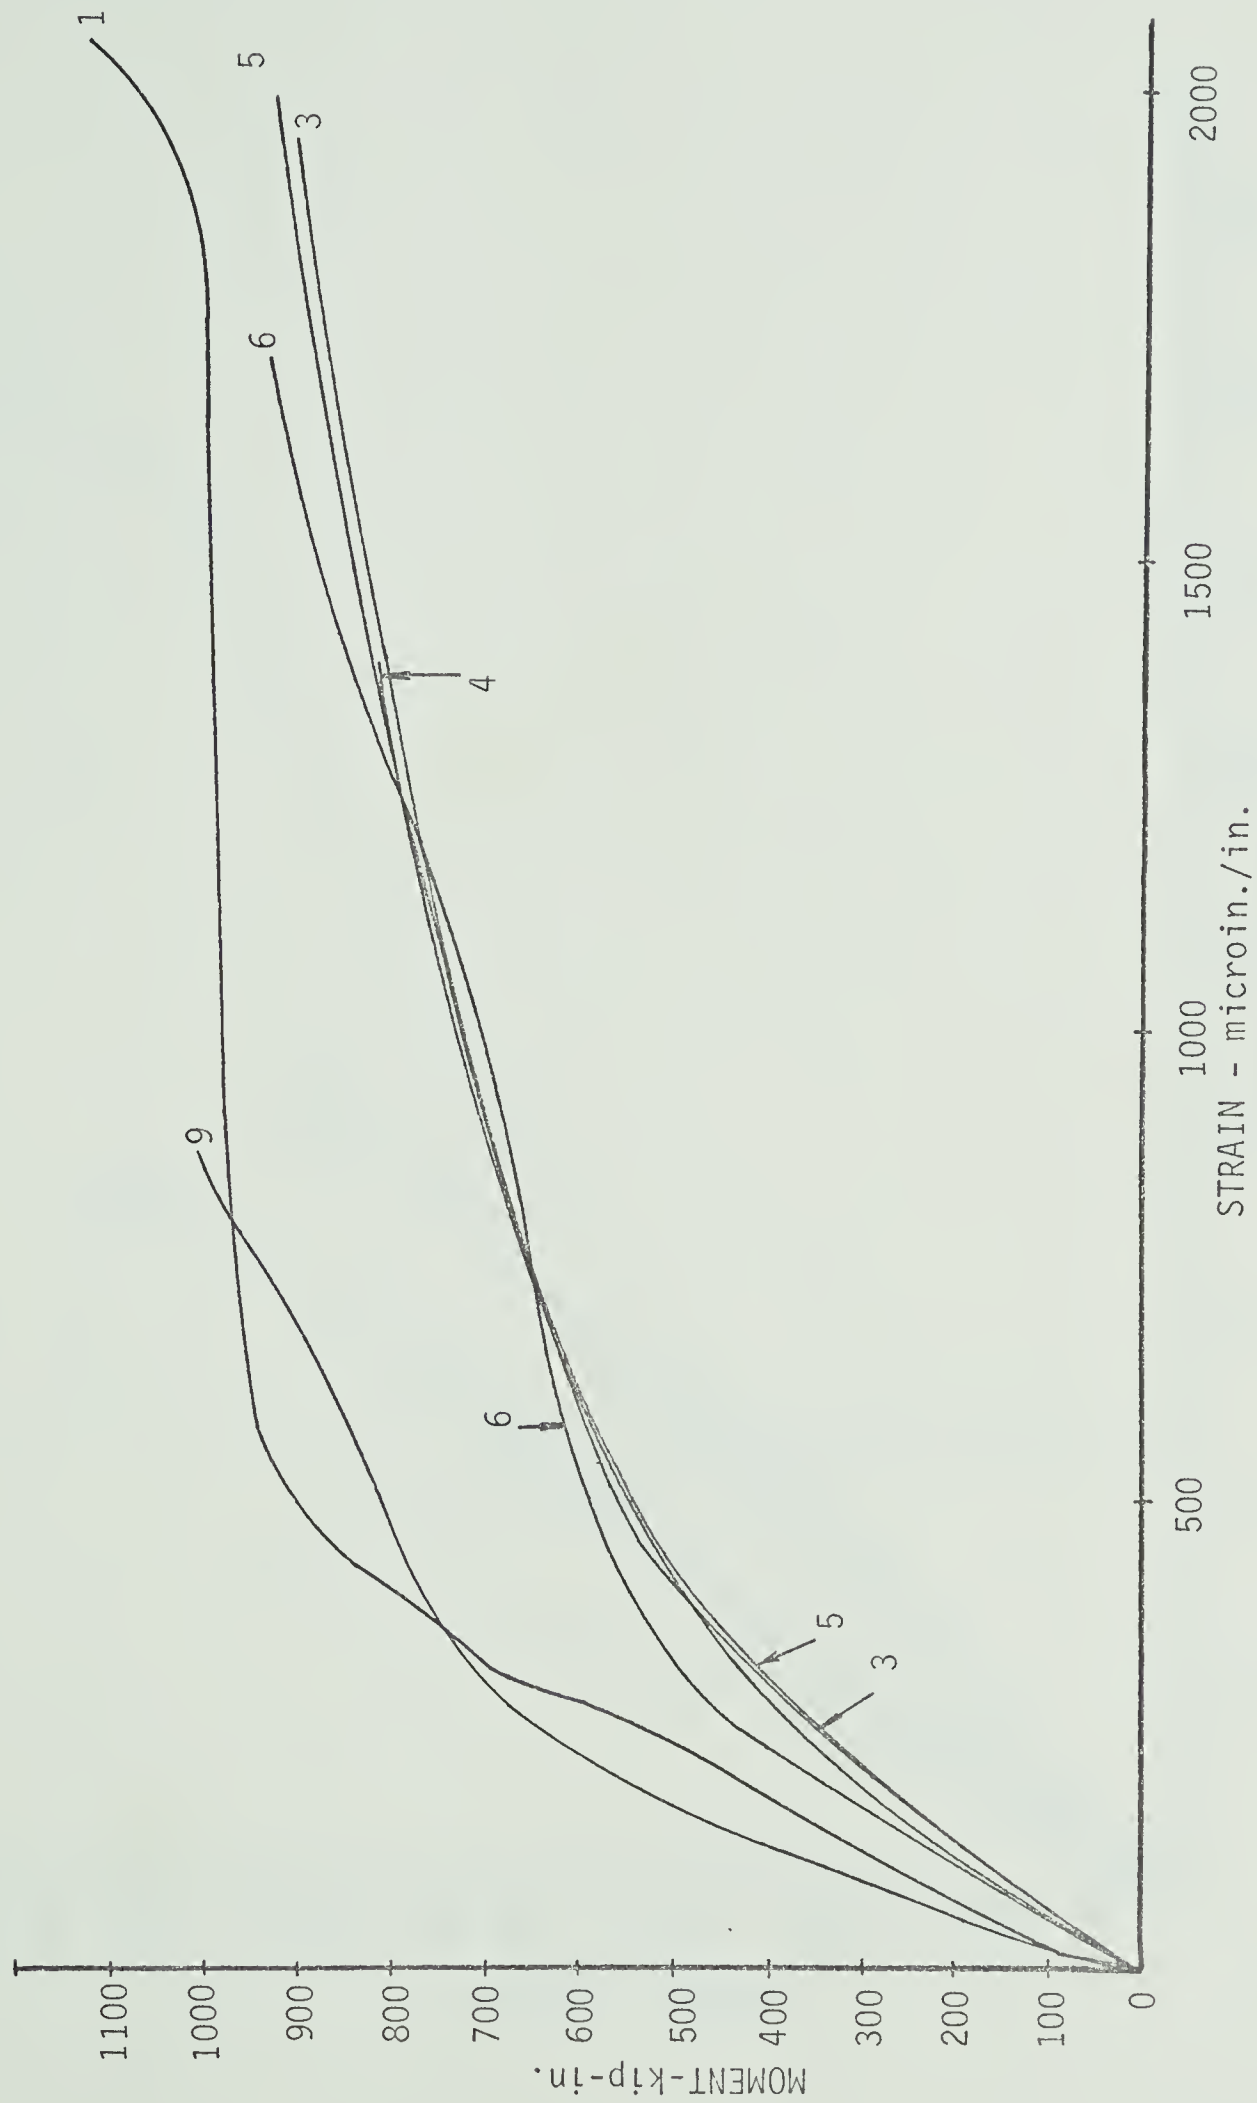
FIGURE 4.3 (a) MOMENT-STRAIN RELATIONSHIP FOR BOTTOM LONGI. REINF. UNDER LOAD POINT

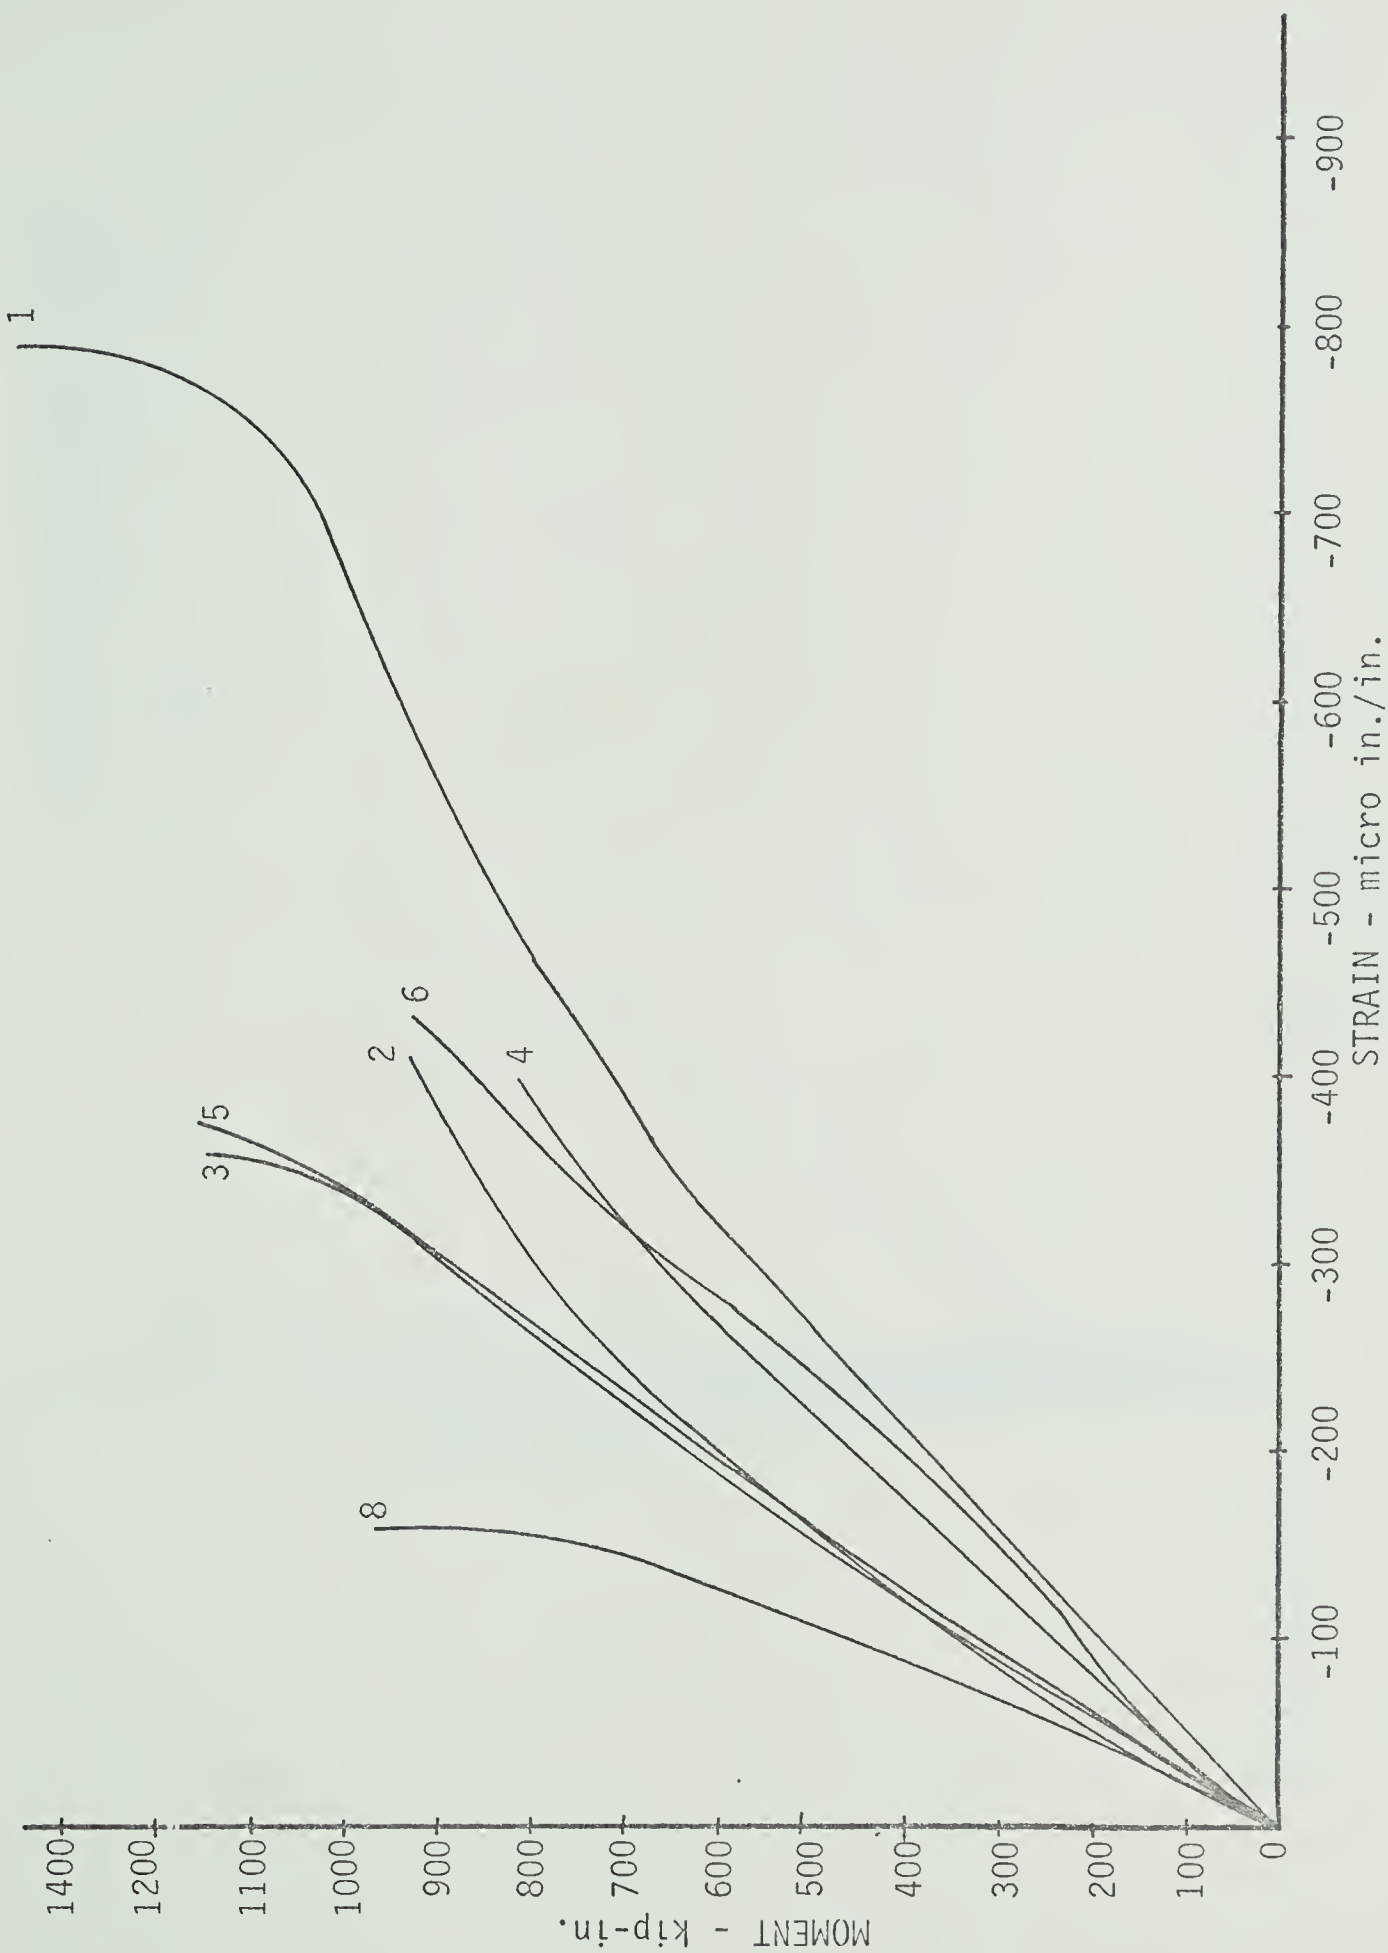
FIGURE 4.3 (b) MOMENT-STRAIN RELATIONSHIP FOR TOP LONGI. REINF. AT CENTERLINE
